# Manhole Inspection Summary

Manhole # S37GG1009MH

Insp Date: **1/10/07 10:20 AM**

**Location** Address: **3937 GREENMOUNT AVE**

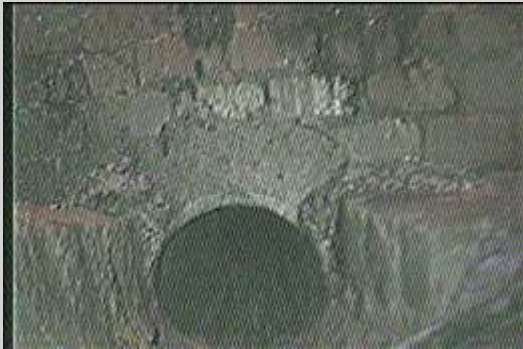
### 8 in. Circular Gravity Sewer Pipe Out @ 12 O'Clock

Rod and Bar (Angled)

Pipe Material: **Clay** ☐ Pipe Lined

Invert Depth: **8.23** (ft.) Flow Characteristics: **Slow**

Infiltration: **None** Pipe Seal Cond: **Unknown**

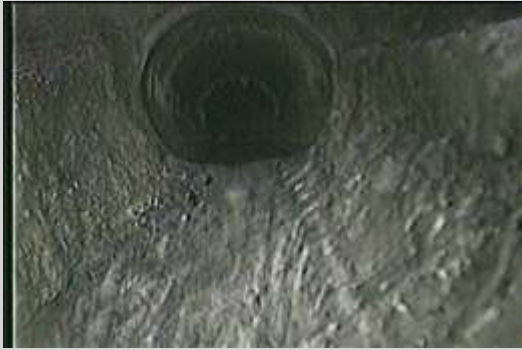
Pipe In @ 6 O'Clock

Rod and Bar (Angled)

Pipe Material: **Clay** ☐ Pipe Lined

Infiltration: **None** Pipe Seal Cond: **Unknown**
